BUILDING SCIENCE SERIES 40

Engineering Aspects of the 1971 San Fernando Earthquake

This report presents the observations of the NBS on-site inspection team (most photographs in this report were taken by the team). The material presented herein is intended to serve as (1) a documentation of damage resulting from the earthquake and (2) as a source document for further studies, research, and recommendations. This is particularly important as necessary remedial work and restoration have resulted in the removal of evidence that is essential for studies and evaluations.

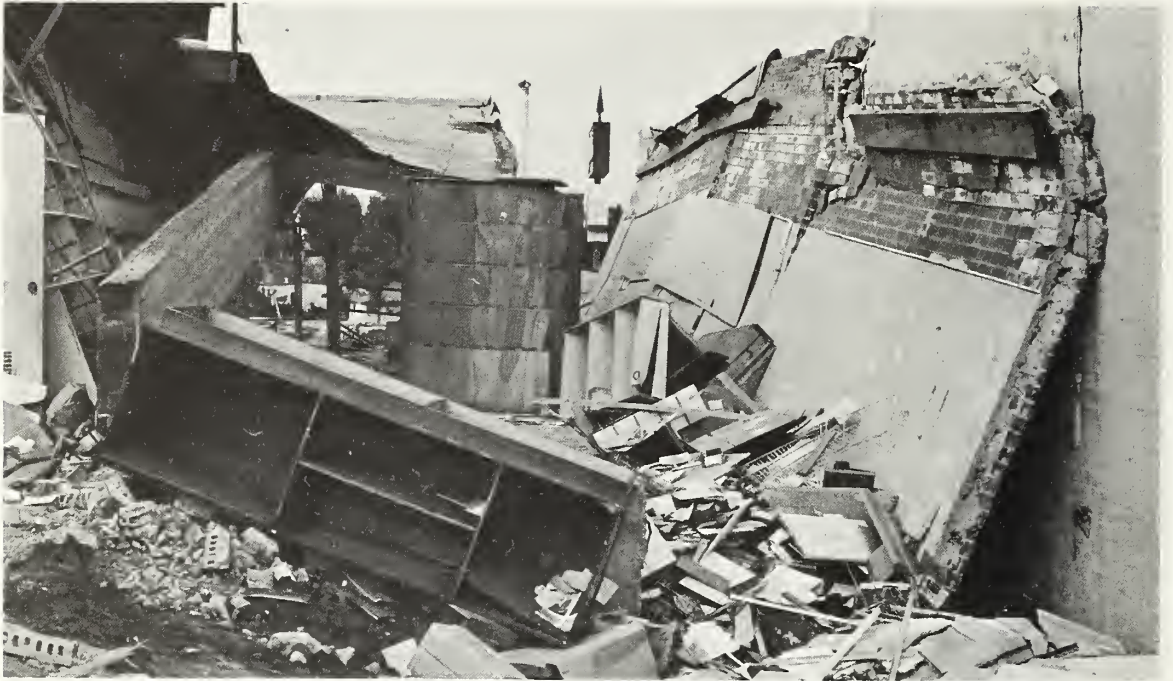
Another small store in the center was similarly damaged as shown in figure 5.133. Note that the reinforced brick masonry wall remained essentially intact even though it fell against an adjacent building. A view from the opposite end of the store is shown in figure 5.134. The laminated timber beam at the left spanned approximately 65 ft from a column at the front of the store to a rear masonry wall which also collapsed. Wood joists spanned from this beam to a wood ledger fastened to the wall on the right. Another view of this store is shown in figure 5.135.

Figure 5.134 Collapsed side wall shown in figure 5.133 as viewed from the rear of the store.

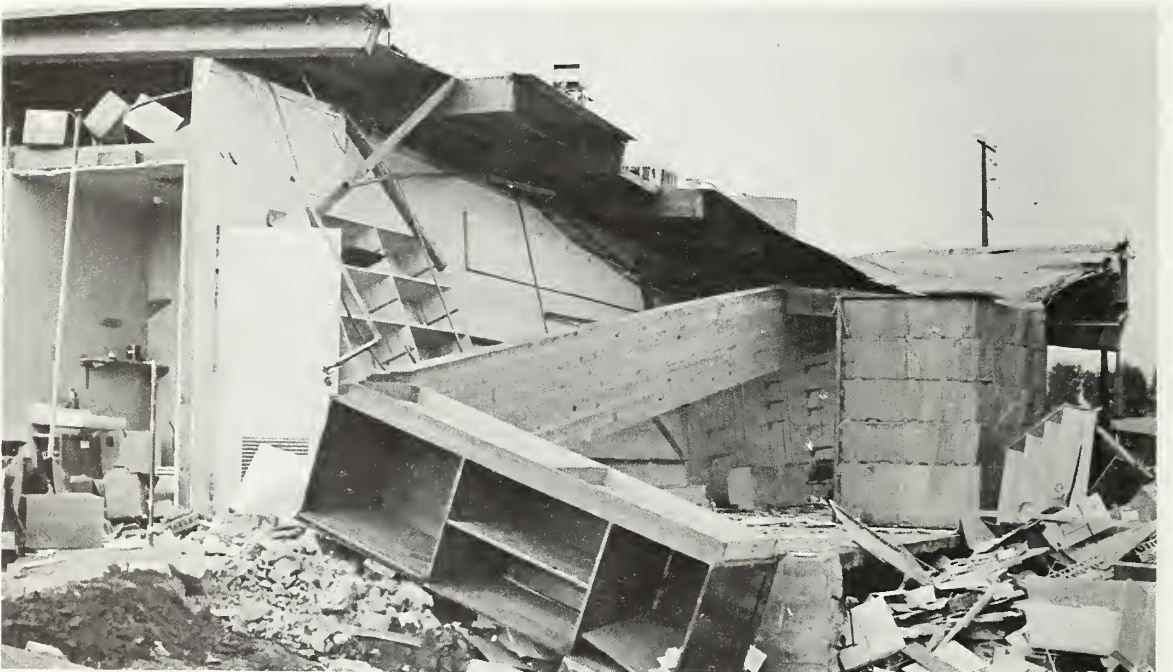
Figure 5.135 Another view of the store shown in figures 5.133 and 5.134.

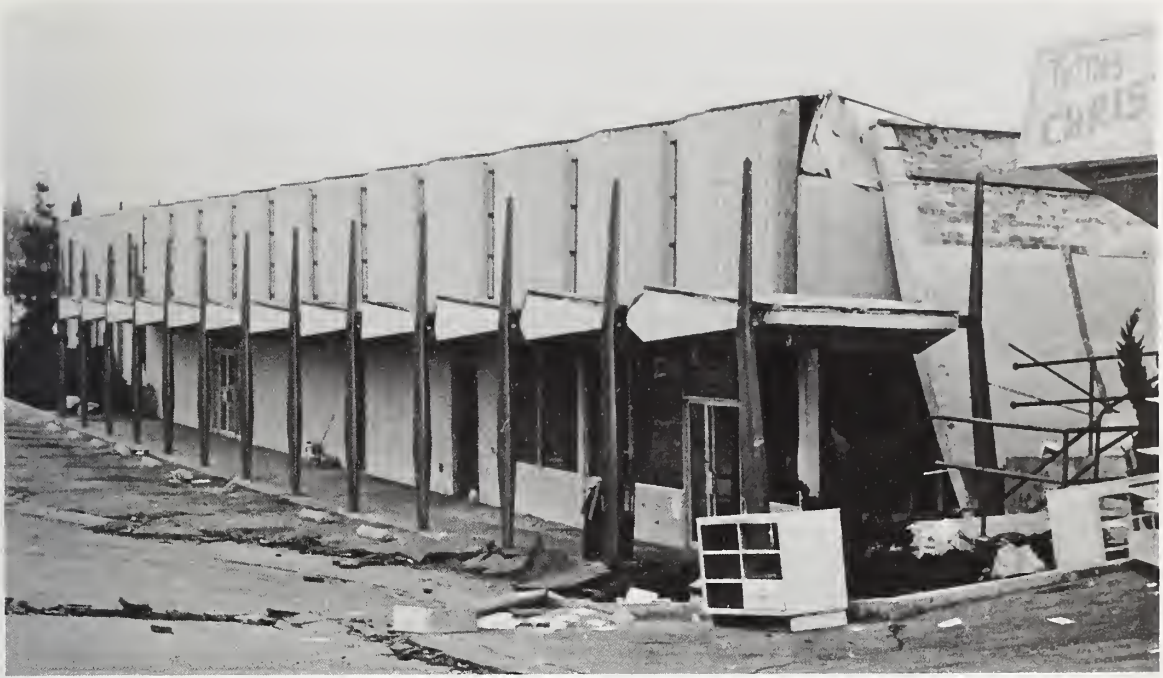
The construction of the southern portion of the center shown in figure 5.136 differed from that described above. This portion had a concrete canopy supported on a light steel frame and was severely racked during the earthquake. The destructiveness of ground shaking can be envisaged by extensive cracking in the parking lot pavement. Yielding and fracture of one of the support columns is shown in figure 5.137.

Figure 5.136 Southern portion of the shopping center.

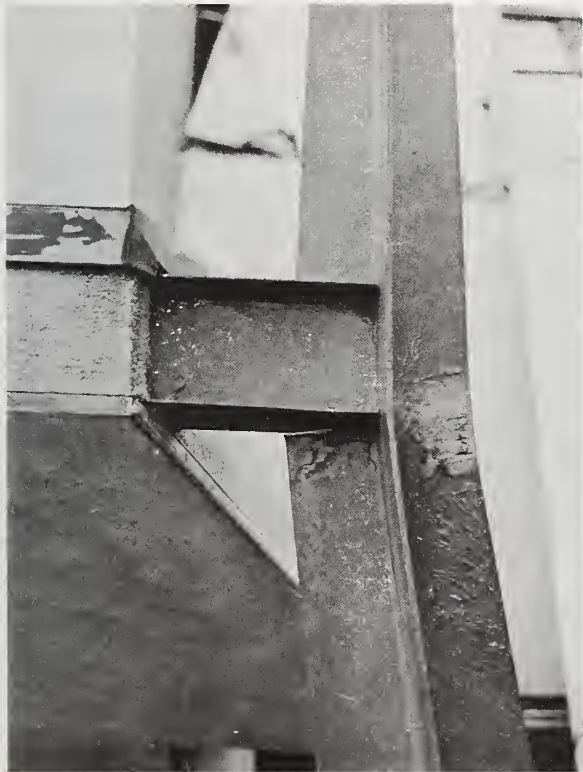
Figure 5.137 Yielded and fractured canopy support.

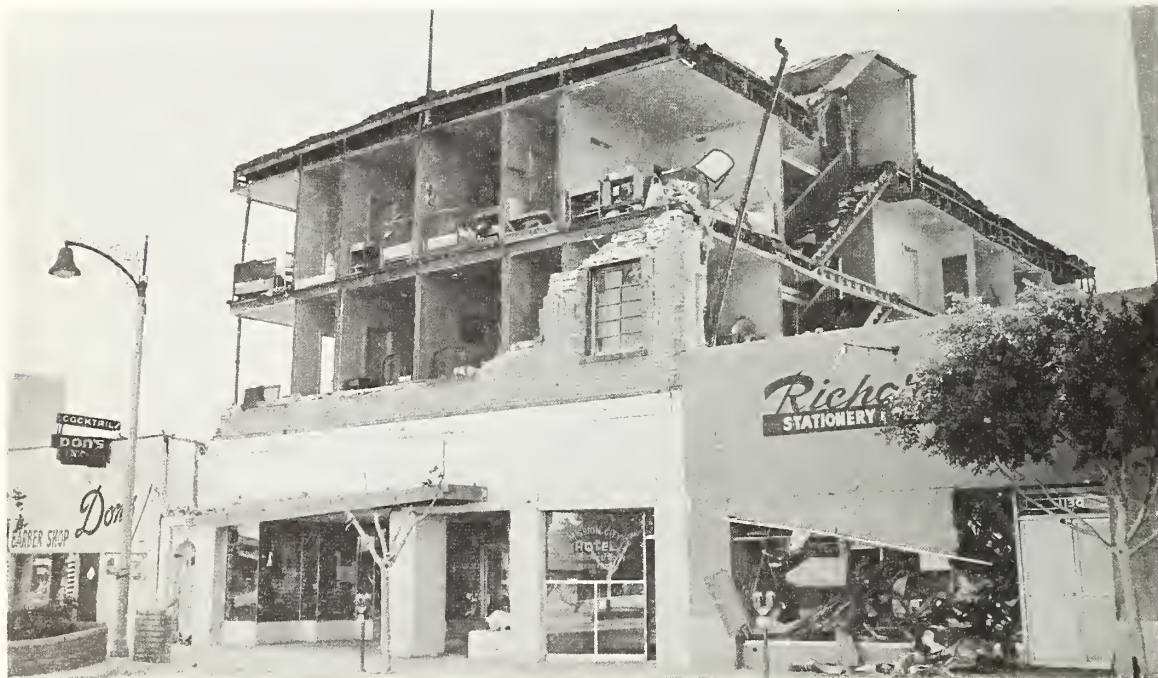
The hotel shown in figure 5.139 was severely damaged. The second story and roof are held up by interior partitions. One of the walls fell through the roof of the adjacent store causing severe interior damage (fig. 5.140). Fallen parapets, walls, and bricks were common as shown in figures 5.141, 5.142, and 5.143. The Kress store was severely damaged as shown in figures 5.144, 5.145, and 5.146. The diagonally cracked wall of Kress shown in figure 5.146 was common in other buildings in the mall as shown in figure 5.147.

Figure 5.139 Total collapse of brick masonry wall surrounding three-story wood frame building (Mission City Hotel).

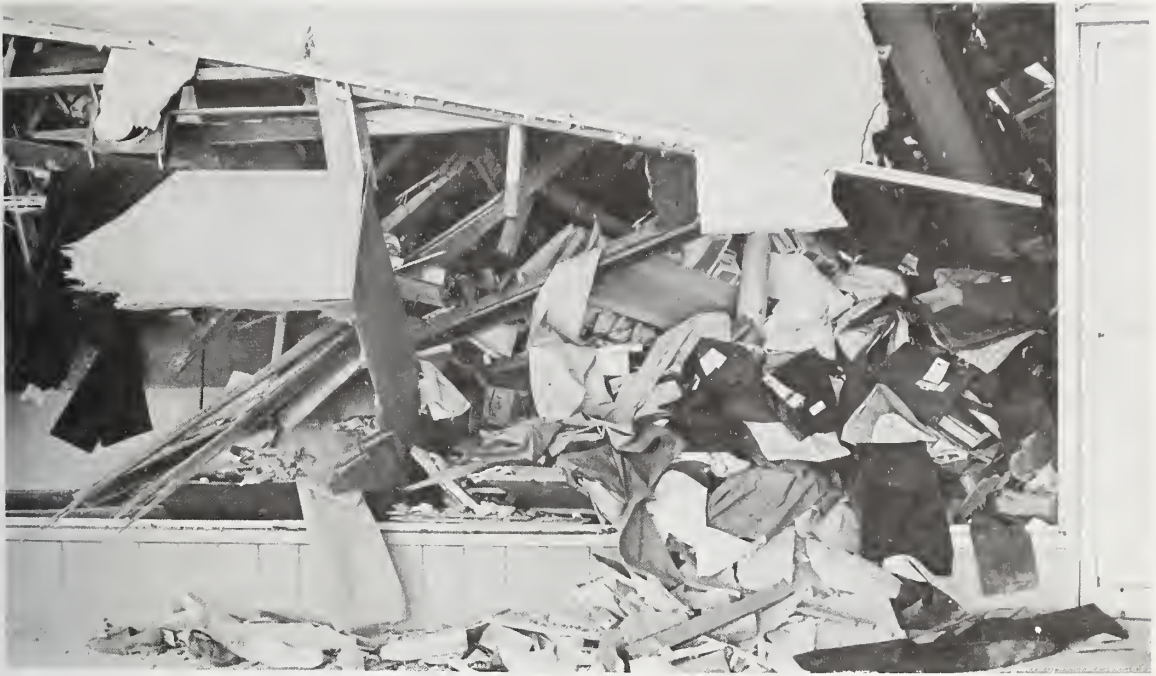
Figure 5.140 The wall of the building shown in figure 5.139 fell through the roof of this building.

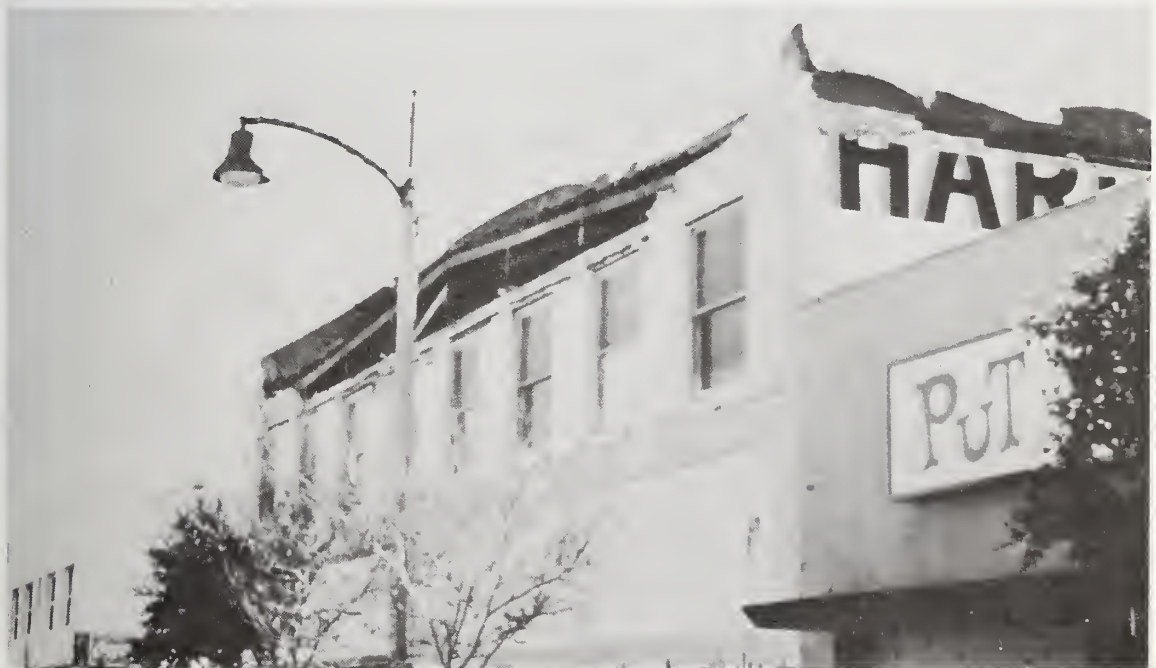
Figure 5.141 Damaged parapet and wall.

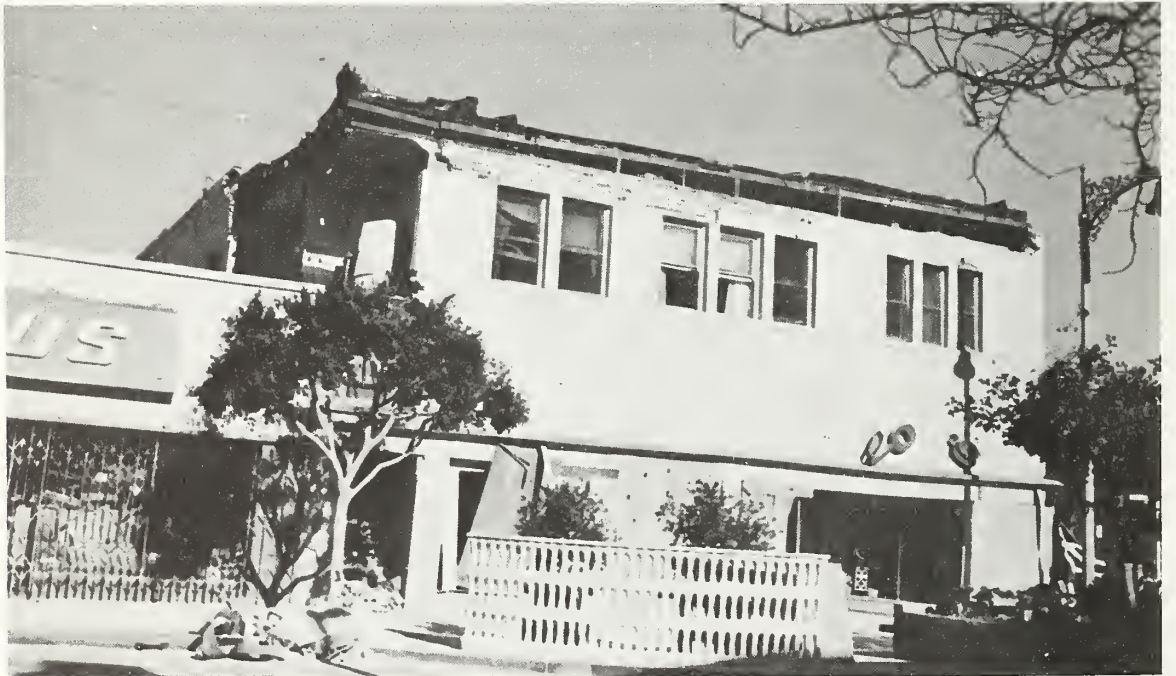
Figure 5.143 Collapsed wall and parapet.

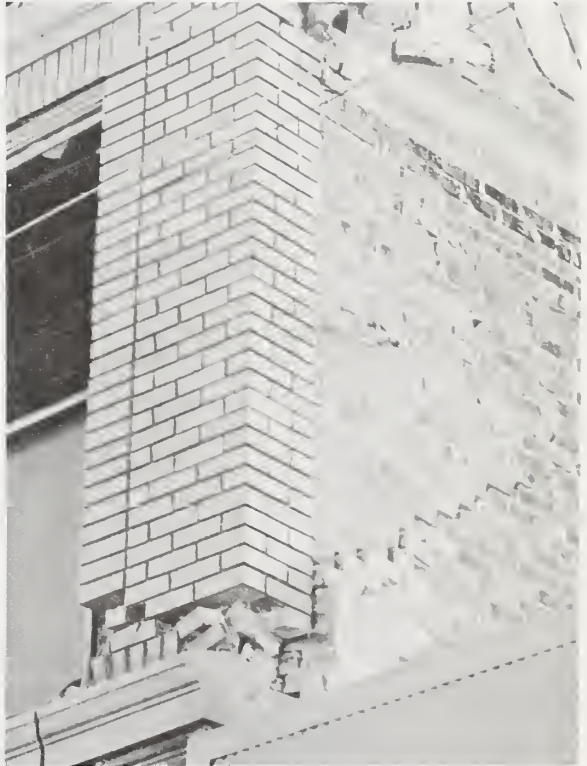
Figure 5.145 Closeup of
damaged brick
wall.

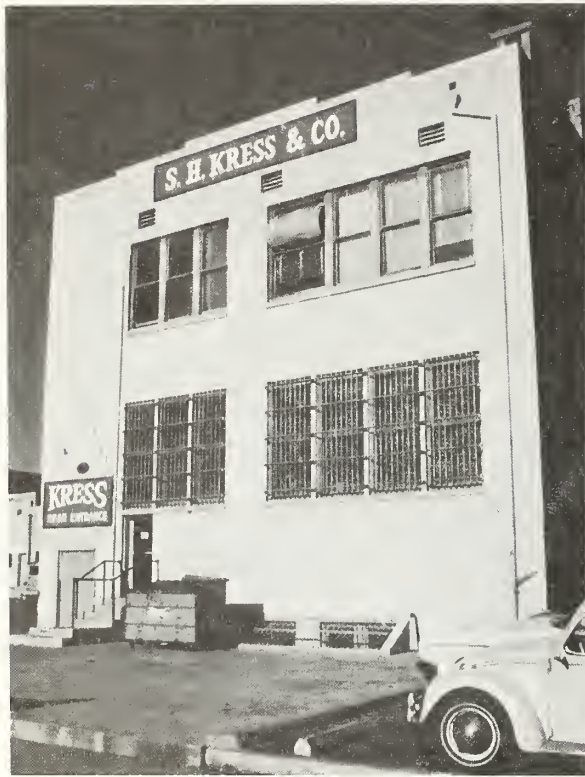
Figure 5.146 Diagonally cracked wall at Kress.

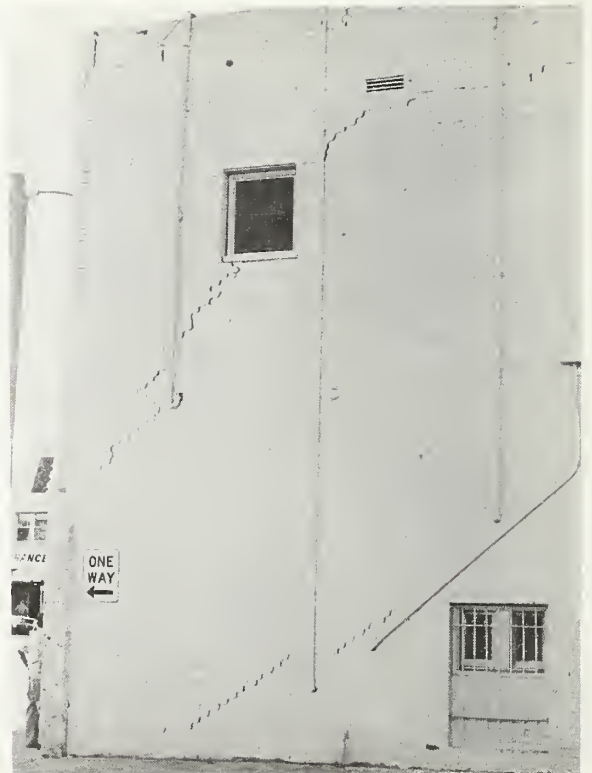
Figure 5.147 Typical diagonally cracked wall.

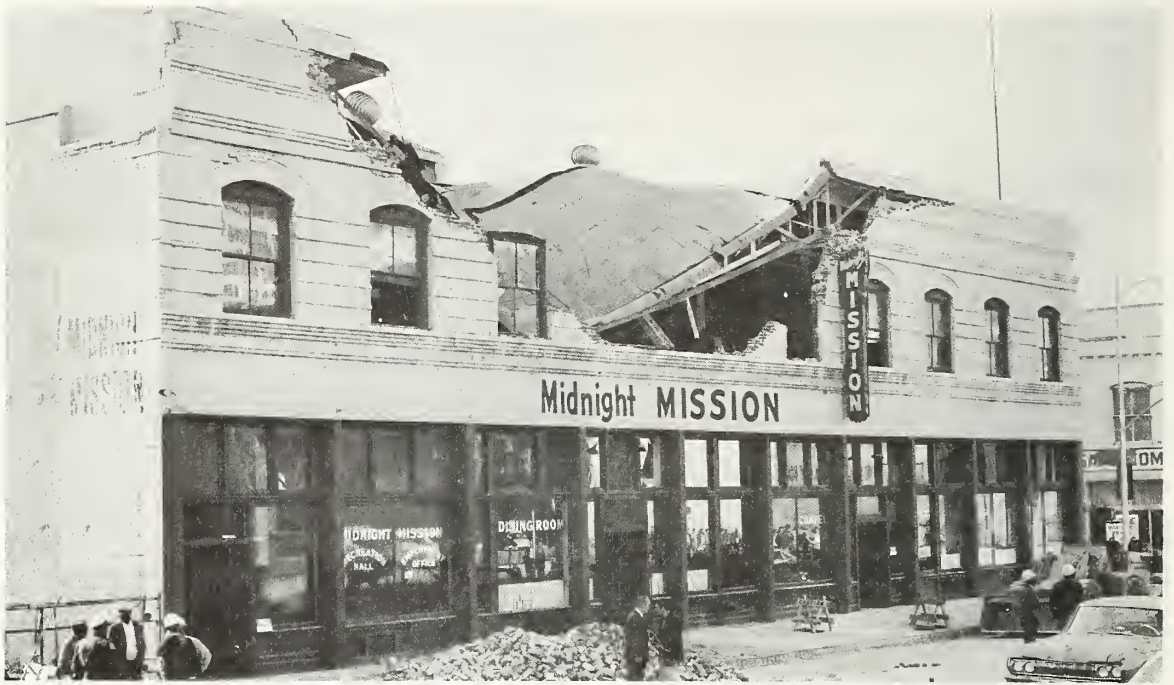
This damage, though severe, was not unexpected considering the type of construction. A similarly constructed building, the Midnight Mission, as far away as downtown Los Angeles was damaged as shown in figure 5.148. At this latter location one man was killed when he ran outside and was struck by falling masonry. Such falling objects are common and dangerous with the pre-1933 masonry construction. It is certainly not typical of modern reinforced masonry construction,

Figure 5.148 Midnight Mission, 396 South Los Angeles Street, in downtown Los Angeles. This building, erected in 1896, provided shelter for about 200 men. One man was killed when he ran out of the front door and was struck by falling masonry. (Los Angeles Times Photo).

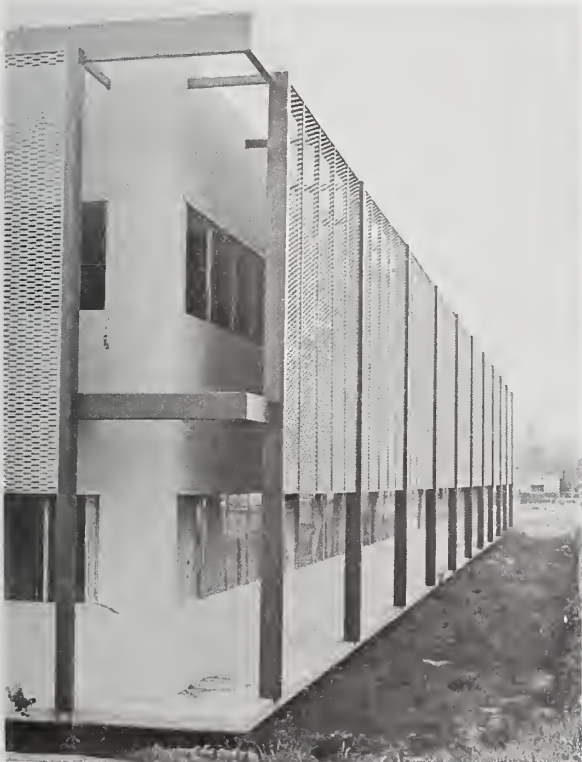
The Foothill Medical Center (see fig. 5.149 and fig. 5.150) is located on Van Nuys Boulevard at Dronfield Avenue, Pacoima. This structural steel frame building (about 65 ft by 200 ft in plan) had considerable glass breakage as shown in figure 5.151. There was also some damage to the stucco covered wood-frame exterior walls as shown in figures 5.151 and 5.152.

*Figure 5.151 East elevation
showing glass
breakage and
cracked exterior
walls.*

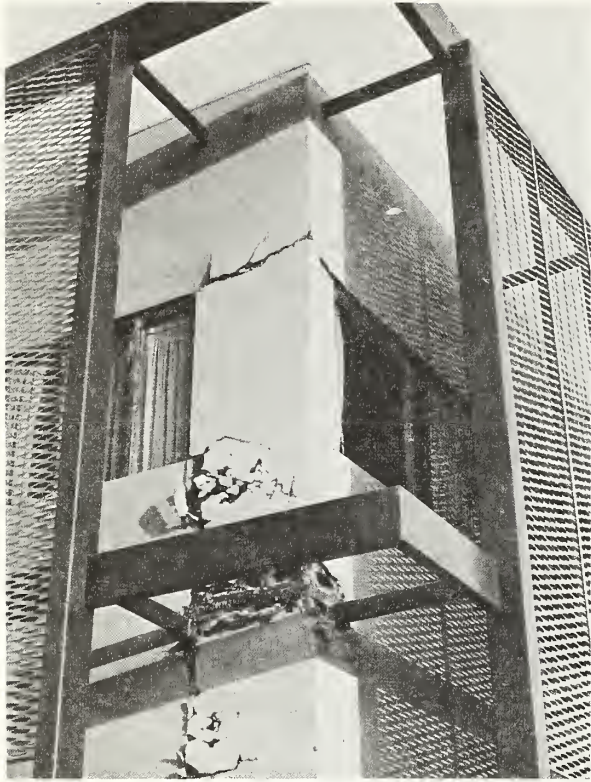
Figure 5.152 Corner damage to the stucco covered wood-frame exterior walls.

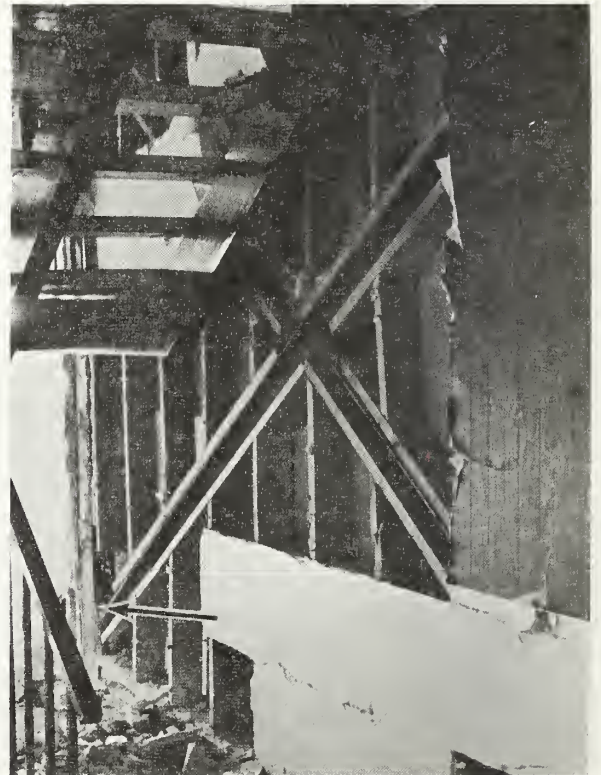
The wallboard had been removed near the entrance to examine the lateral bracing (fig. 5.153). While the bracing showed no evidence of damage, the exposure revealed local flange buckling of the steel column as indicated by the arrow. There was considerable damage to interior partitions and stairwells (fig. 5.154).

Figure 5.153 Interior view of lateral bracing. The arrows locates local flange buckling at the bottom of the steel column.

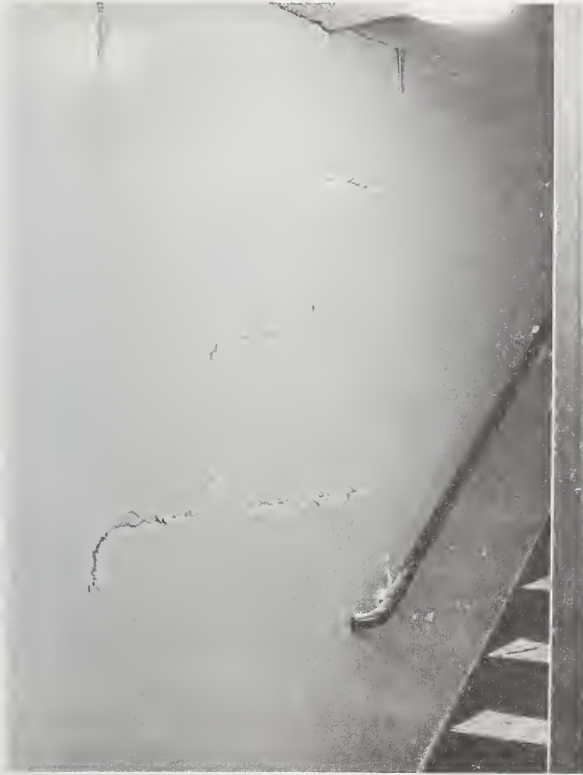
Figure 5.154 Wallboard cracking in stairwell. The cracking pattern reflects the size of the wallboard.

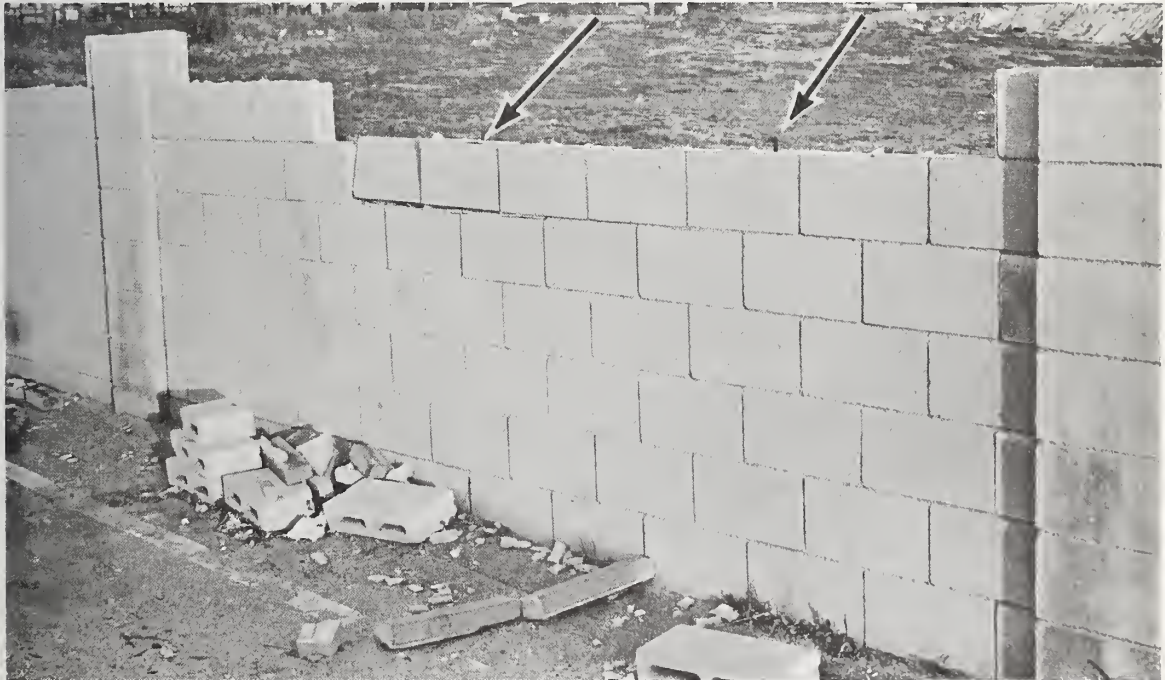
The reinforced concrete masonry wall shown in figure 5.155 was on two sides of the center parking lot. The wall reinforcement did not always extend to the top of the wall and reinforced cells were not always grouted. Usually blocks above the reinforcing cut off were toppled (indicated by arrows). Walls were usually leaning when reinforced cells were not grouted.

Figure 5.155 Reinforced concrete masonry wall around the Medical Center parking lot. Arrows indicate the location of vertical reinforcement.

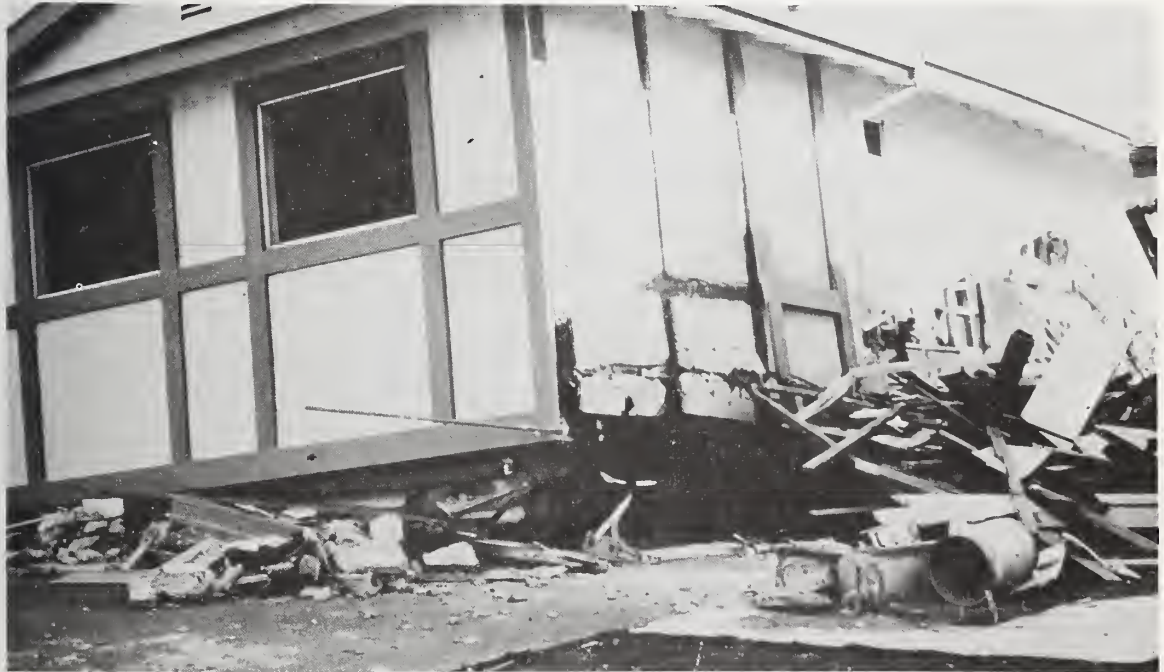
Split-level houses frequently collapsed as in the case of the house shown in figure 5.157 (map 3, location 5). This house was similar in appearance to the one shown in figure 5.158 which was not damaged. Other damaged split level houses (map 3, location 6) are shown in figures 5.159, 5.160, and 5.161. A similar house located slightly farther south (map 3, location 12) is shown in figure 5.162. In general, split-level or irregularly-shaped houses that were not adequately tied at the changes in roof or floor elevation were severely damaged either by collapse or at the junction of the wings (fig. 5.161). Collapse frequently occurred due to a wide open-space provided by the garage door in the end wall, which offered little lateral resistance (fig. 5.162).

Figure 5.157 Collapsed split-level residence at Fenton Avenue and Tyler Street.

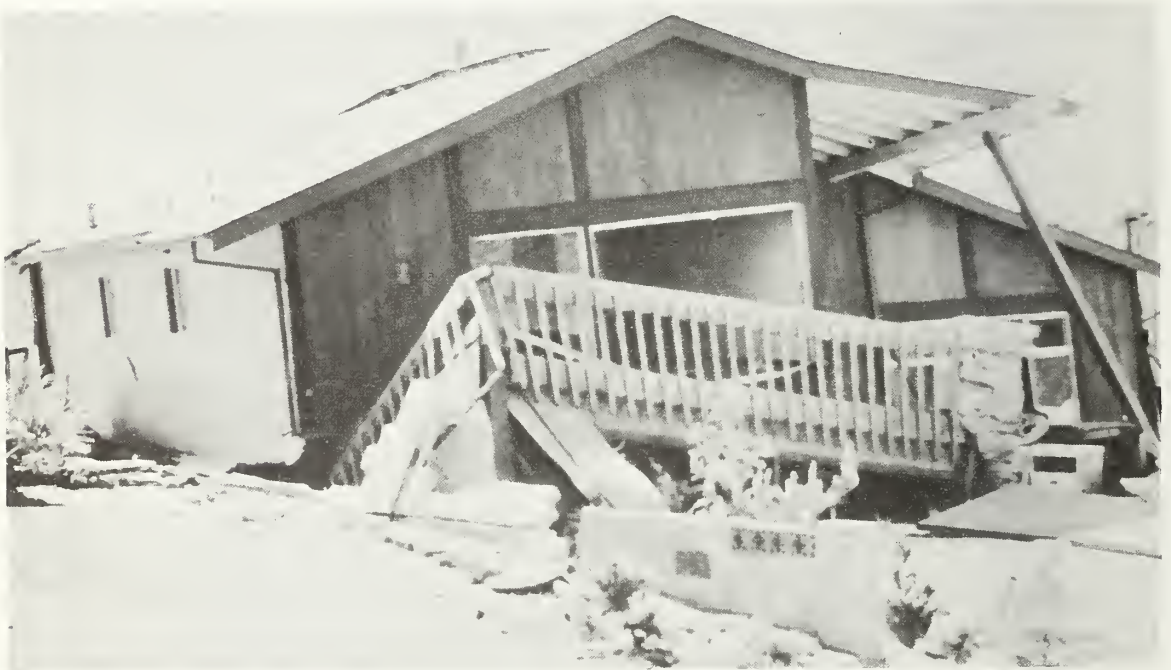
Figure 5.159 Collapsed split-level residence at Almetz Street and Leedy Avenue.

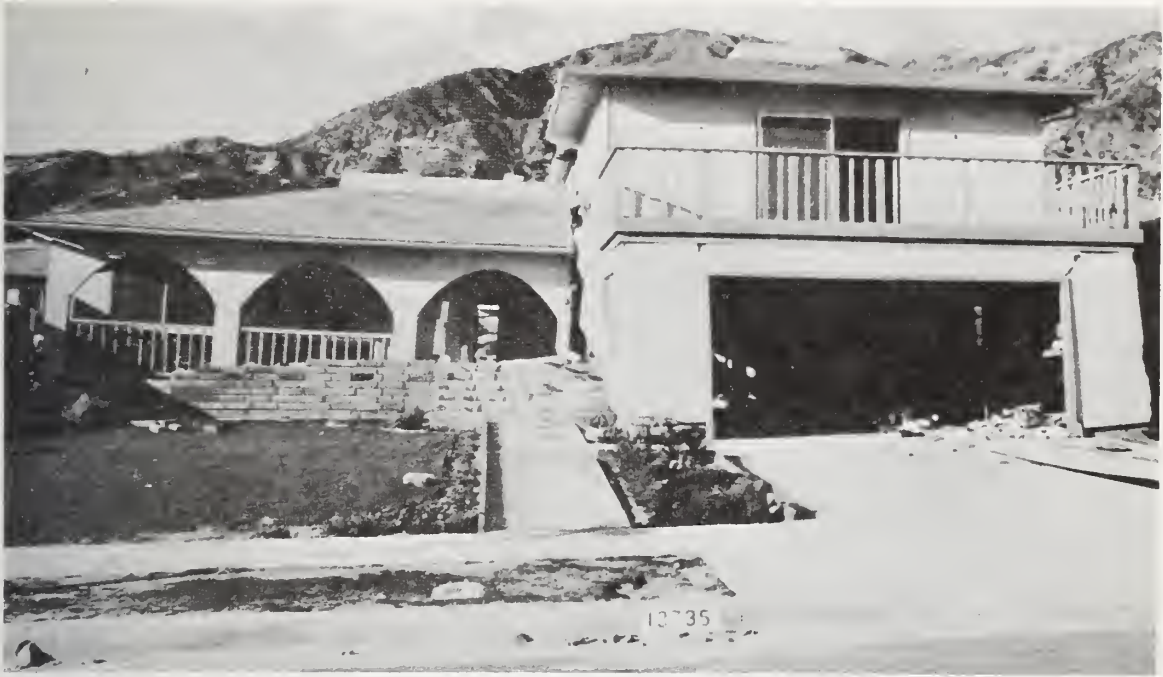
Figure 5.160 Damaged split-level residence at Aldergrove Street and Leedy Avenue.

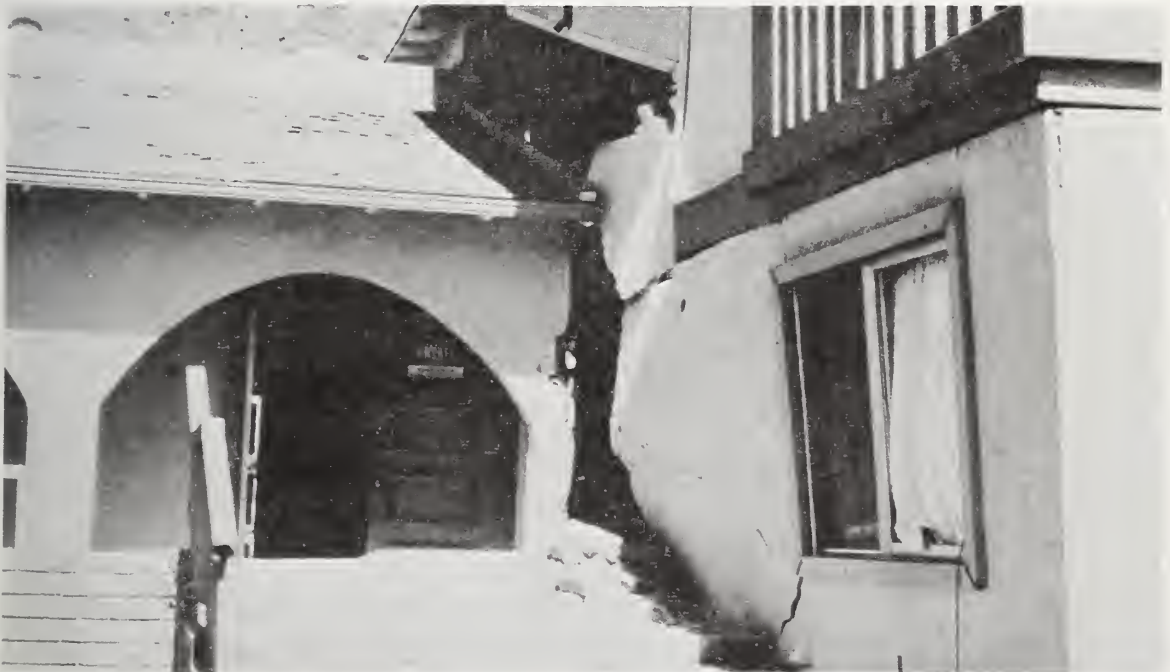
Figure 5.161 Closeup of damaged split-level residence shown in figure 5.160.

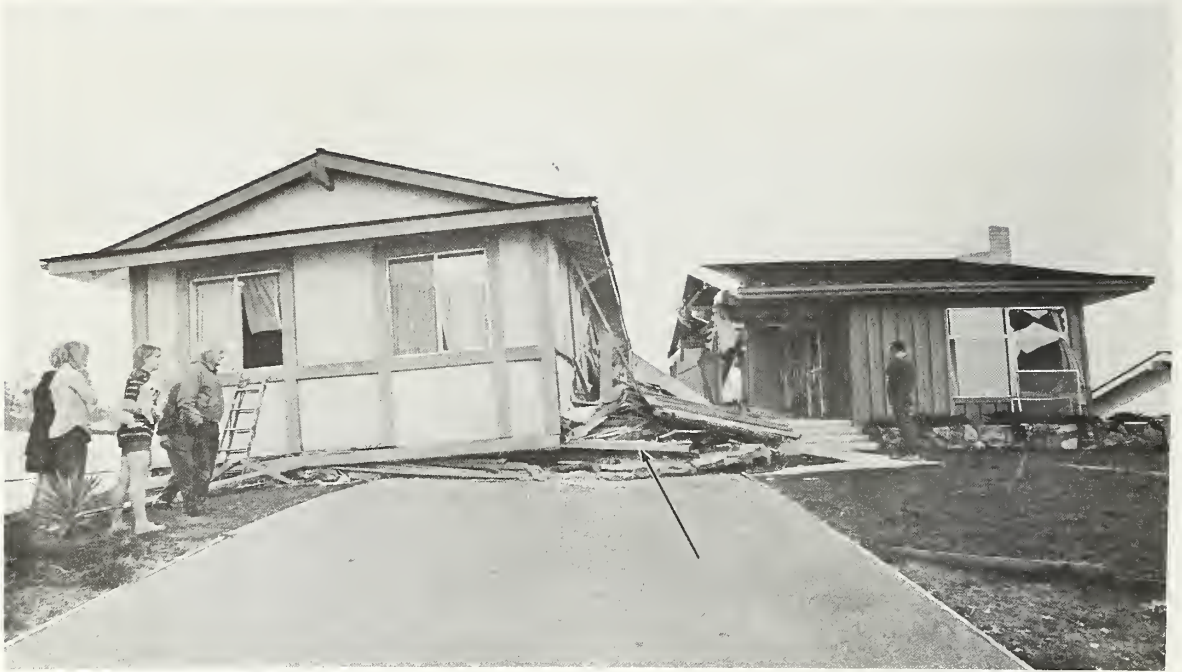
Figure 5.162 Split-level residence, Sylmar. Note crushed car (arrow). (Los Angeles Times Photo).

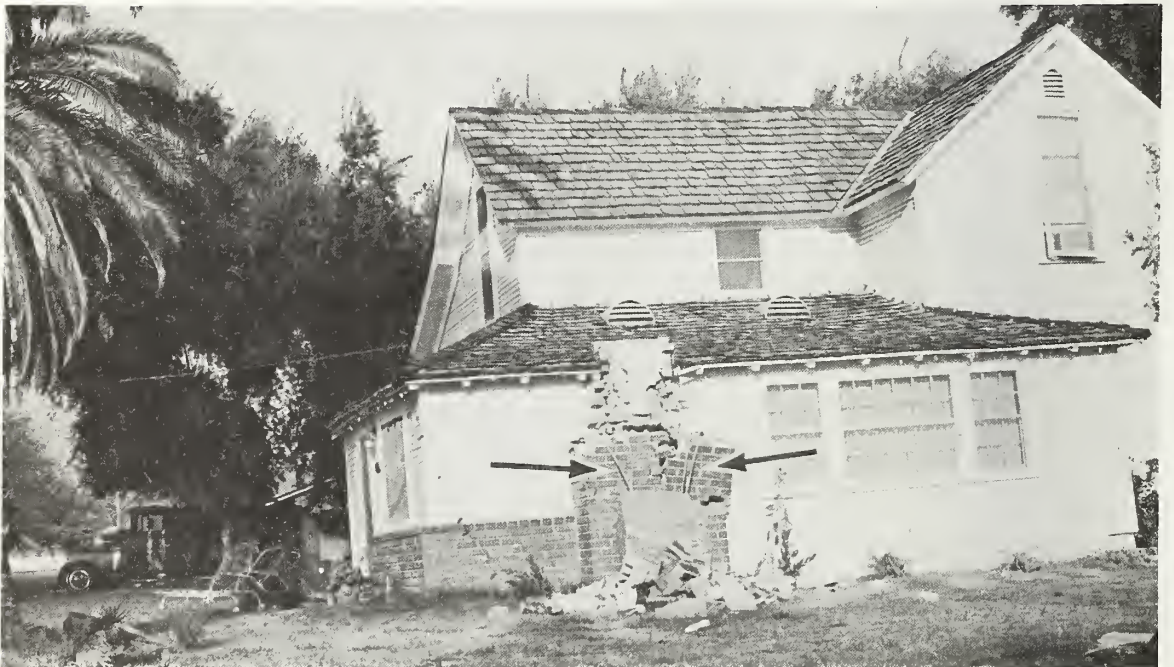
Masonry chimneys on many residences collapsed as shown shown in figure 5.163 (map 3, location 10). Leaning chimneys were not uncommon as shown in figure 5.164 (map 3, location 11) when they were properly reinforced but inadequately tied to the house. Note the collapsed masonry fence in front of the house.

Figure 5.163 Damaged reinforced brick masonry chimney (arrows indicate reinforcement).

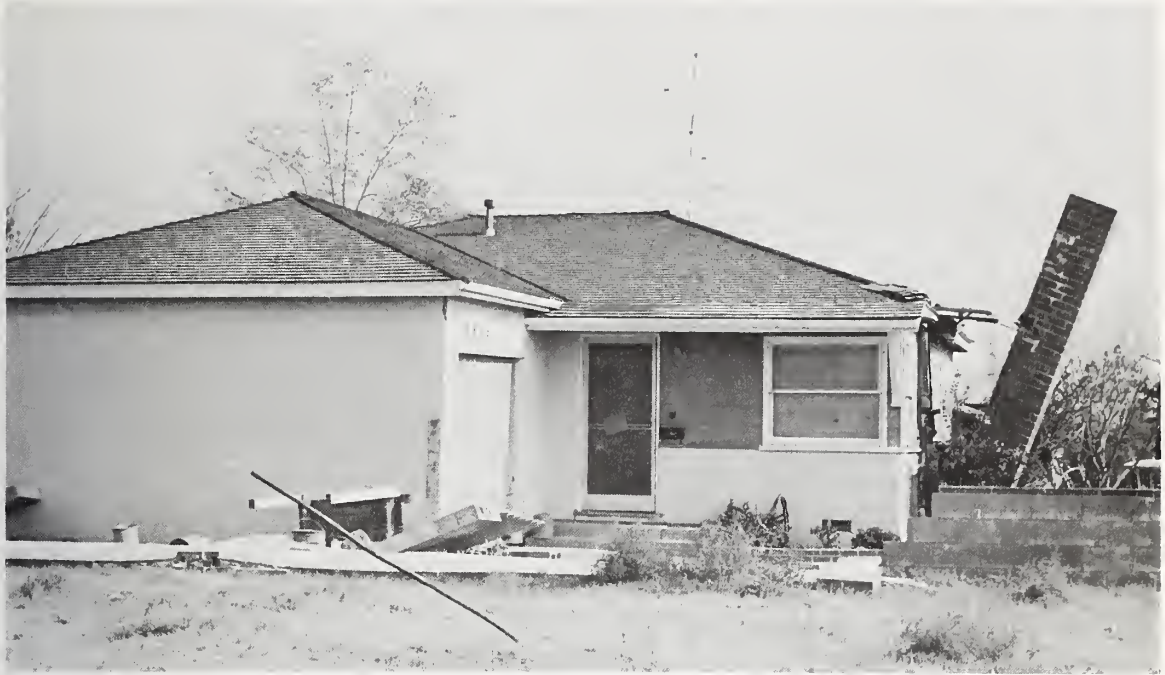
Figure 5.164 Leaning reinforced brick masonry chimney.

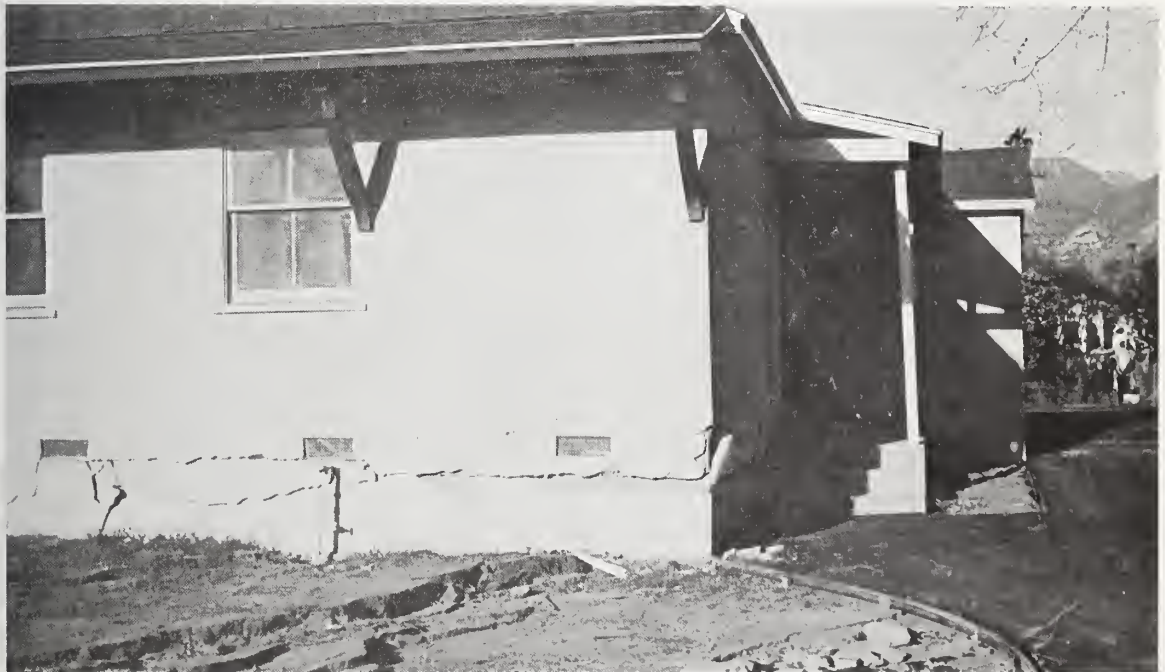
Figure 5.165 Wood-frame and stucco house on 8th Street, San Fernando. Horizontal cracking occurred along the top of the foundation wall. Note ground cracking in left foreground.

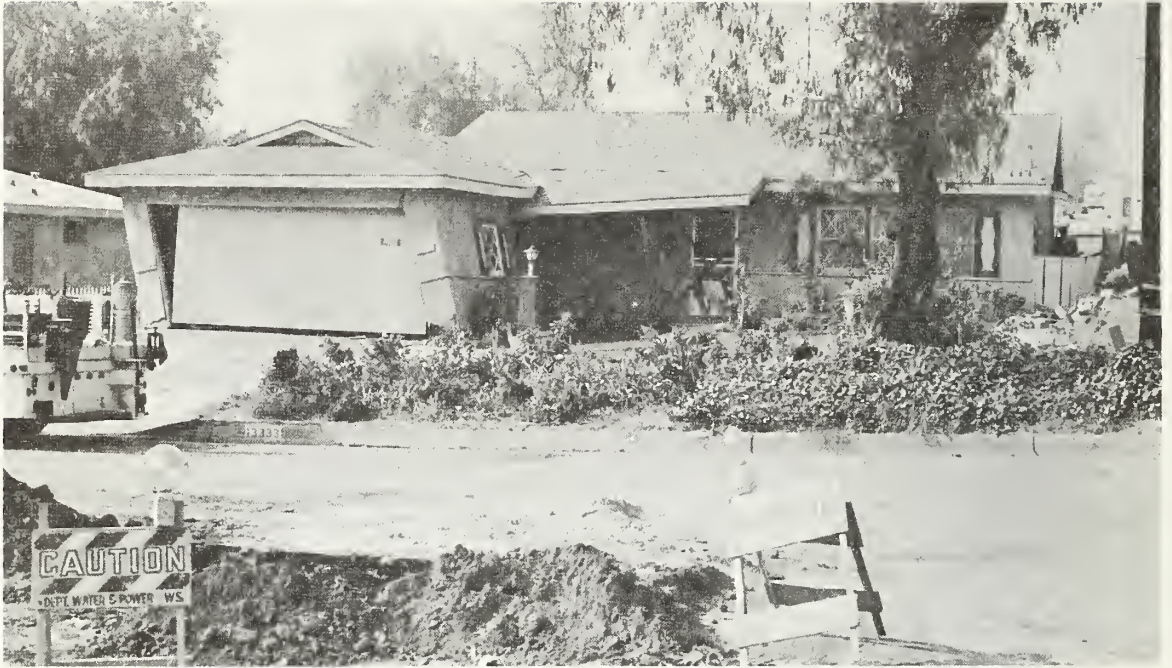
Figure 5.166 Damaged single family residence.

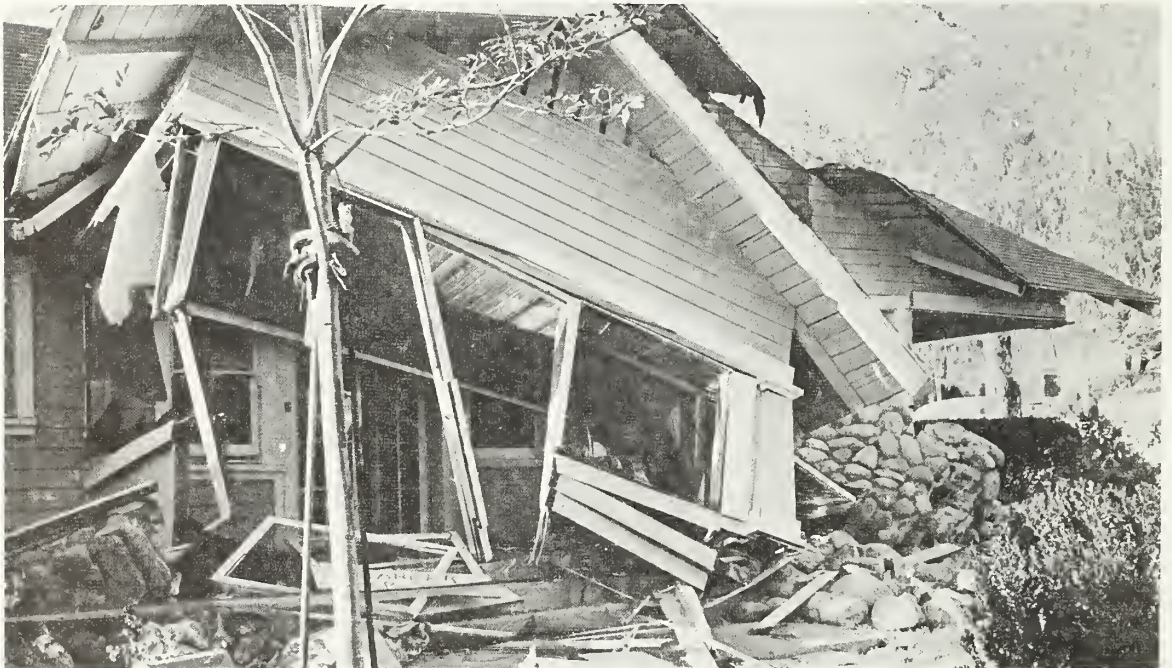
Figure 5.167 Destroyed wood-frame house.

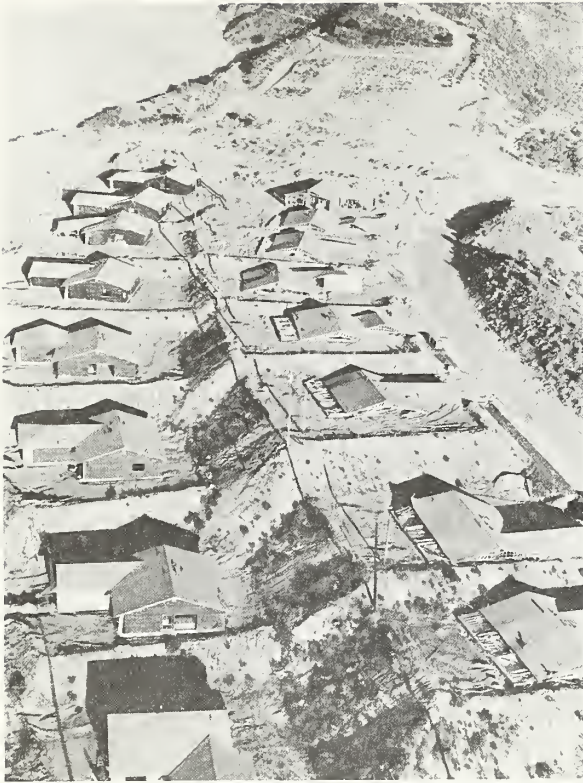
One group of partially completed residences located east of and adjacent to the San Fernando Veterans Hospital (map 3, location 8) was heavily damaged as shown in figure 5.168. The frames and roofs were essentially complete at the time of the earthquake. The walls of the houses on the left were covered with wire mesh and paper backing which was to be covered with stucco (in a few cases decorative plywood panels were also installed). This covering was essentially the only difference from the houses on the right which collapsed. It appears that a very nominal amount of material furnished considerable lateral support. (The house in the right rear background which did not collapse was apparently no different than those which did collapse. The reason it remained standing is not known.) A partially collapsed house is shown in figure 5.169.

Figure 5.168 Housing development under construction.

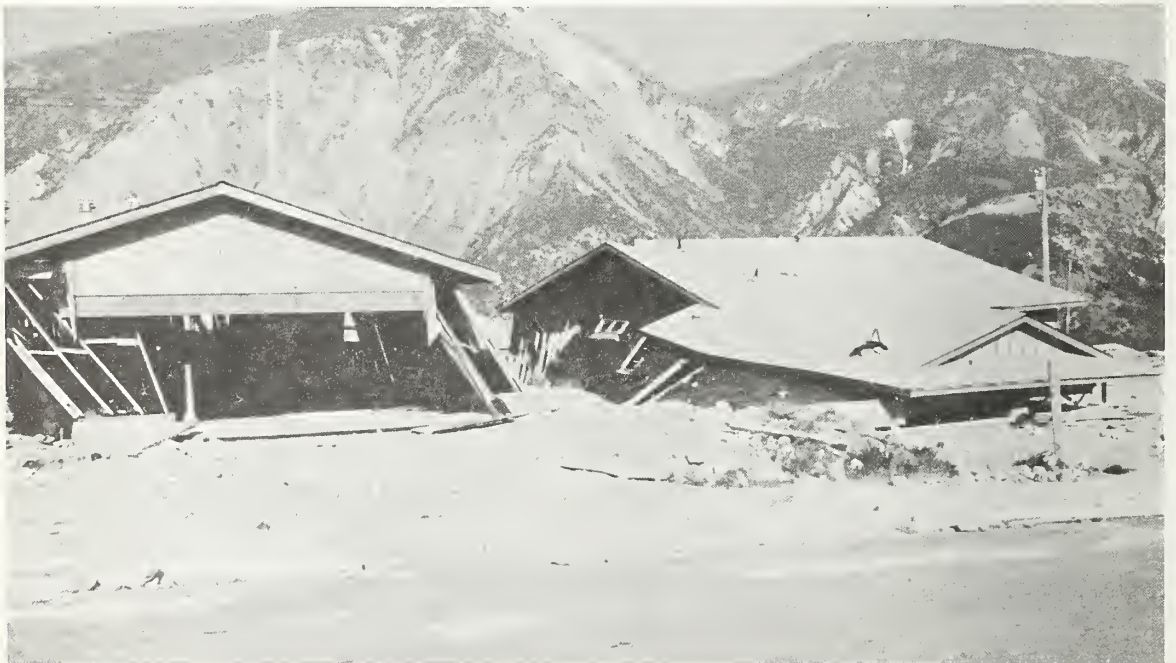
Figure 5.169 Partially collapsed houses under construction.

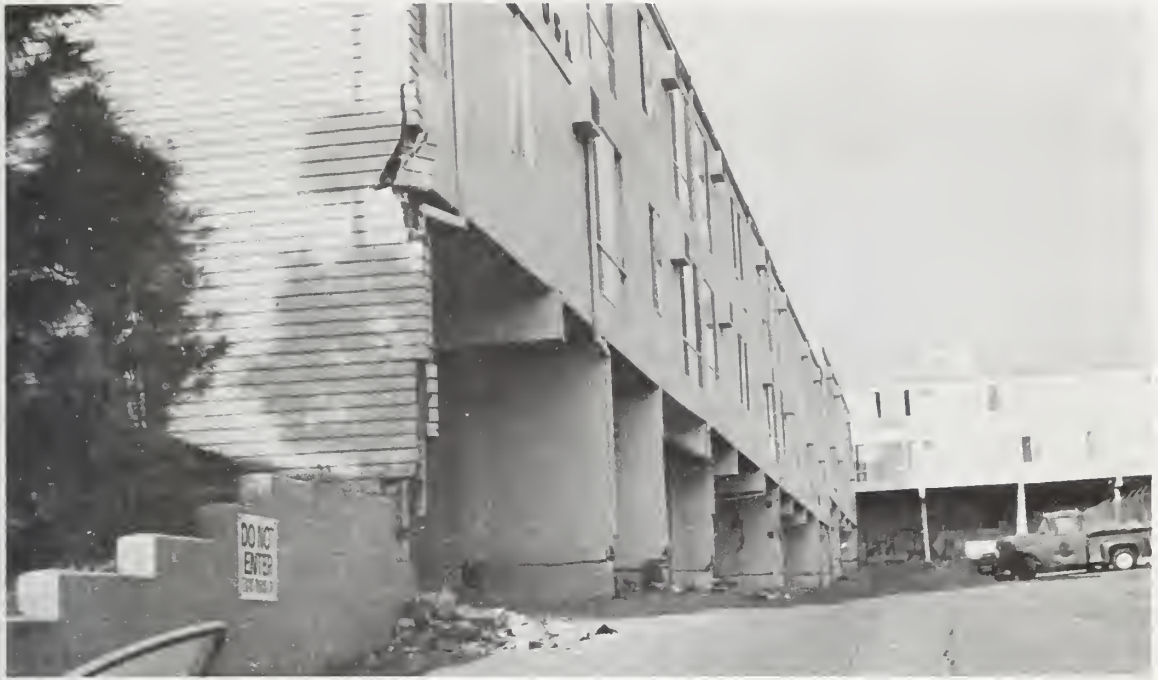
Apartments differ little in construction from houses. The "Friday USA" Apartments (map 3, location 14) suffered severe damage as shown in figure 5.170 due to little lateral resistance provided by large open-garage areas in the first floor. The Mardette Apartments (map 3, location 16) were similarly damaged as shown in figures 5.171 and 5.172. The wide open parking areas and entranceways provide little lateral resistance as in the case of split-level houses previously discussed.

Figure 5.170 Rear view of damaged three-story "Friday USA" apartment building.
